**SETBACKS FROM SLOPE CRESTS
FOR STRUCTURES**

MUNICIPAL AFFAIRS
Innovative Housing Grants Program

March 1991

D. M. CRUDEN AND J. S. DE LUGT
University of Alberta

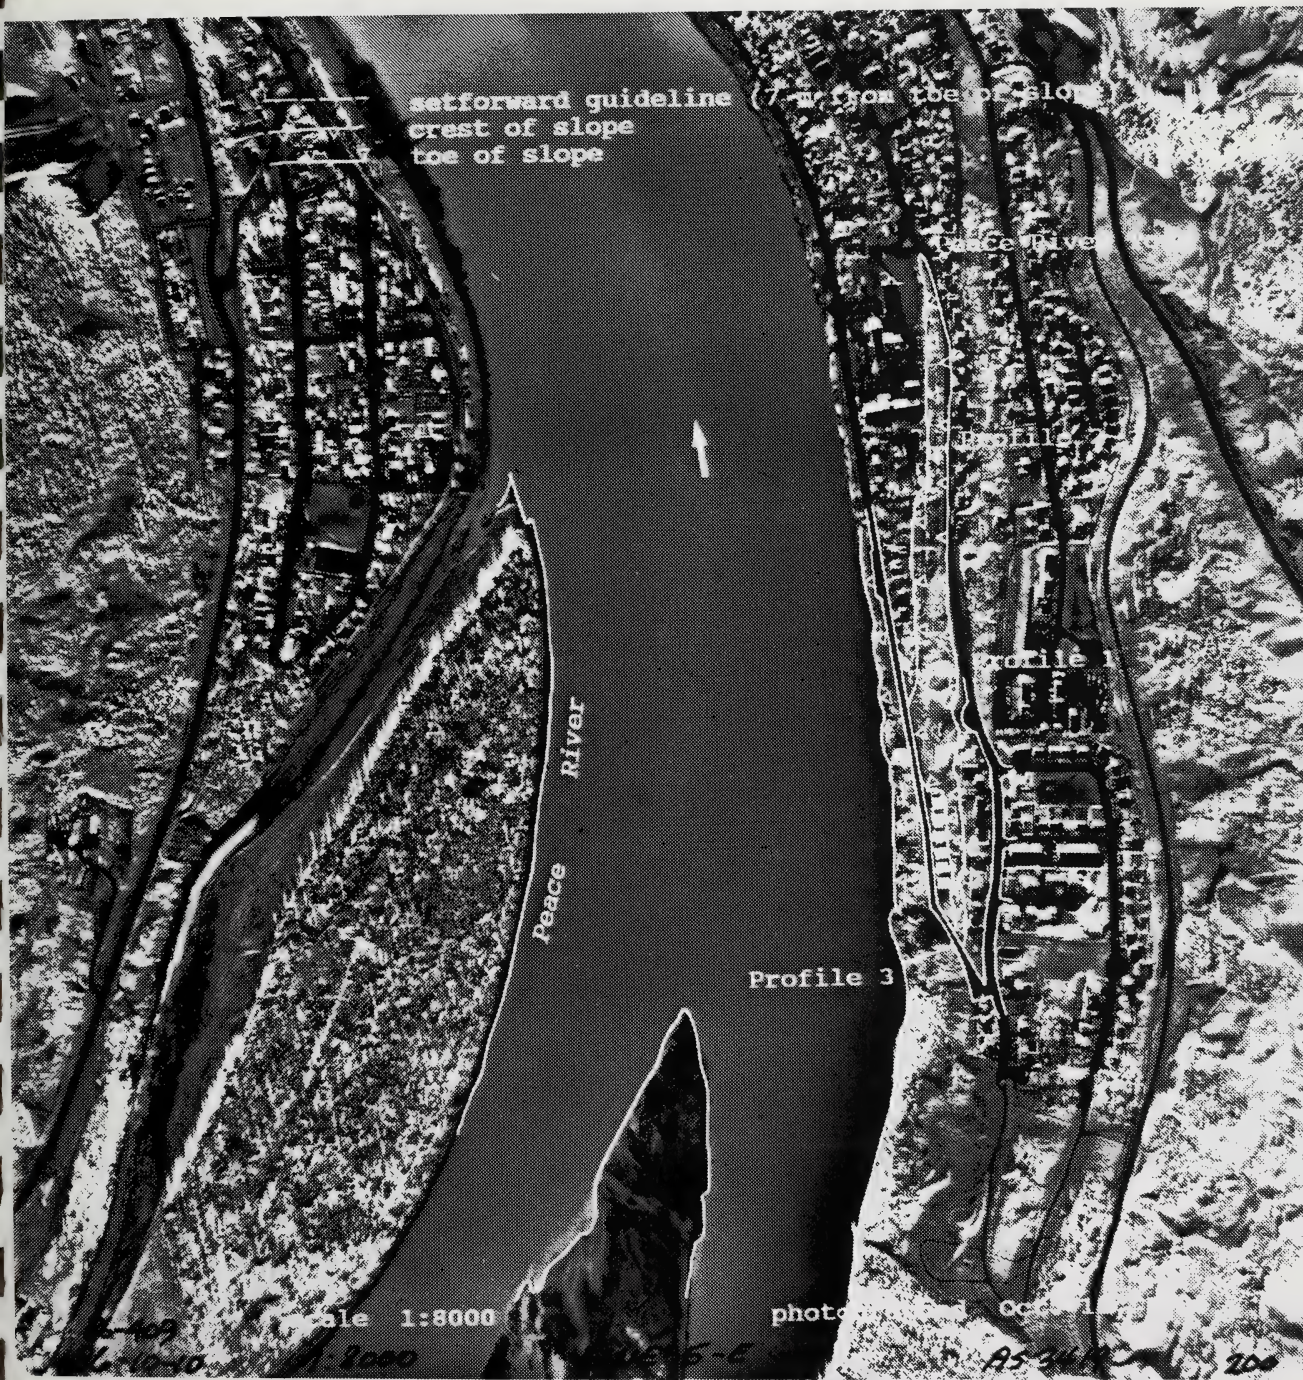
Figure 4: Setforward Guideline for the 99th Street Landslide

The second landslide example from Peace River Town occurred in the same residential subdivision two years later. This case history is different from the other case histories in that the houses damaged by the landslide were at the base of the slope. The slope movement is likely a response to the oversteepening of the slope behind the houses to increase the depth of the lot. A further factor likely was the infilling of a small ravine. Retaining walls behind the houses were damaged, and the northernmost house was pushed off its foundations.

Till overlies sands and gravels, which overlie the competent Cretaceous sandstone (Barlow et al., 1990). The failure also exposed areas of fill. This slope is classified as an overburden slope, indicating that the groundwater level would be expected to be at or below the base of the slope.

The slope has been stabilized. Horizontal drains have been installed and surface water has been diverted. Muskeg Creek has been straightened (eliminating four meanders) and realigned to prevent further erosion of the toe of the slope.

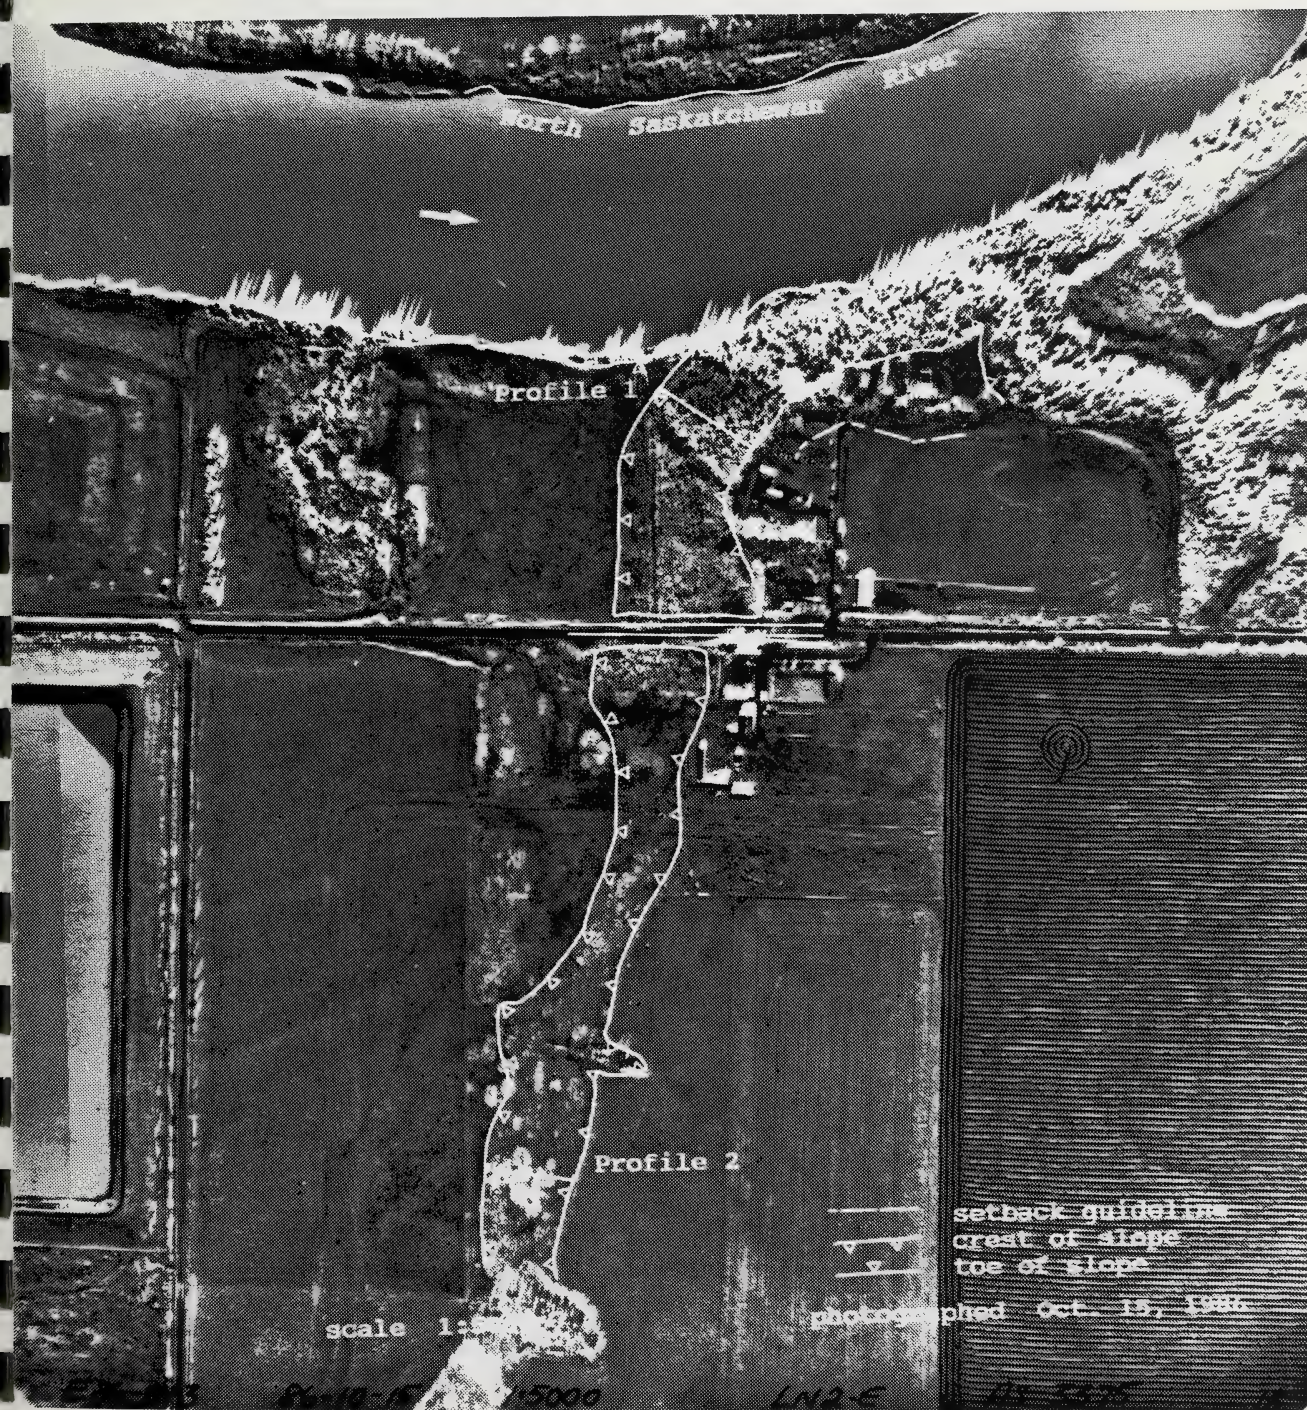
Figure 5: Setback Guideline for the Lesueur Landslide

In the 24 years since the slide occurred, the crest of the scarp retreated a total of about 23 m suggesting that 67 m is a conservative, but reasonable setback estimate. Figure 5 indicates the setback generated by the model, and its effect on land use in the immediate vicinity of the landslide. Accordingly, development above the valley wall might be restricted for an area of about 9,000 m².

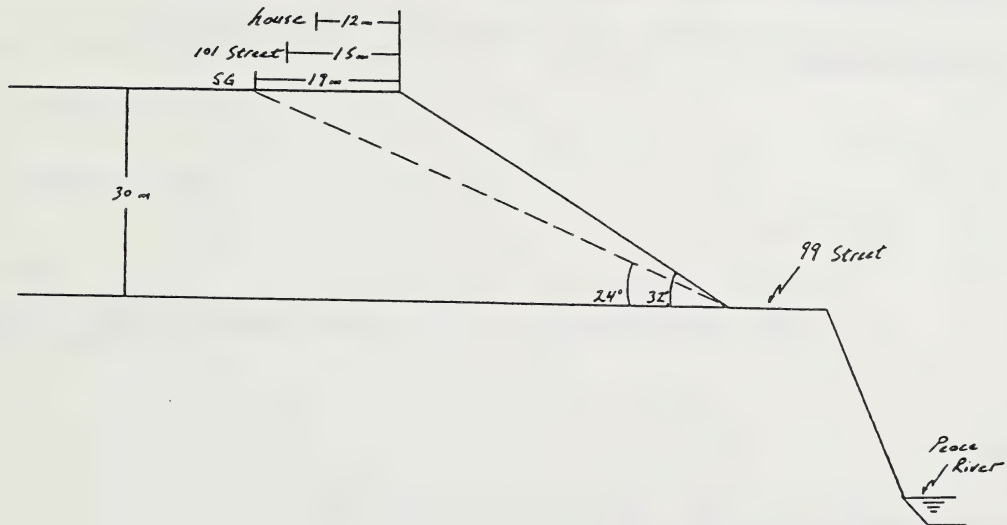
101 Street Slide, Peace River Town

The 101 Street Landslide, occurred in 1987 and affected the house adjacent to its south flank. The main scarp of the slide was within 2 m of 101 Street, and within 6 m of the nearest residence. This landslide was triggered by heavy rains although unstable conditions existed prior to failure. Many of the landslides in this area are a result of a combination of adverse site conditions and site grading activities undertaken by the developer (Barlow et al., 1990). In this particular case, the slope regrading activities of the 1960's reactivated the slide. In the late 1960's up to 5 m of soil was excavated from the toe for the widening of 99 Street, and in 1968 up to 7 m of fill was placed at the crest of the slope during subdivision development.

Hs - slope height = 30 m (Barlow et al., 1990)

Bu - ultimate angle of stability = 24°

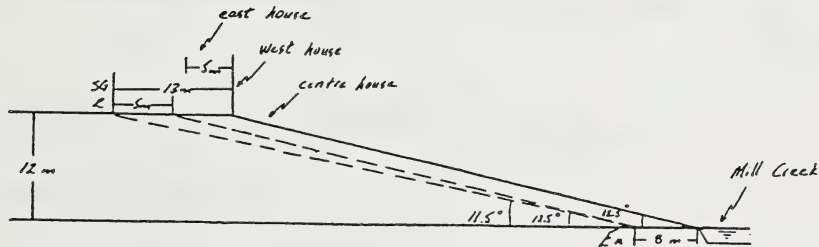
76th Ave. at Mill Creek, Edmonton

Hs - slope height = 12 m (orthophoto measurement)

β_u - ultimate angle of stability = 11.5°

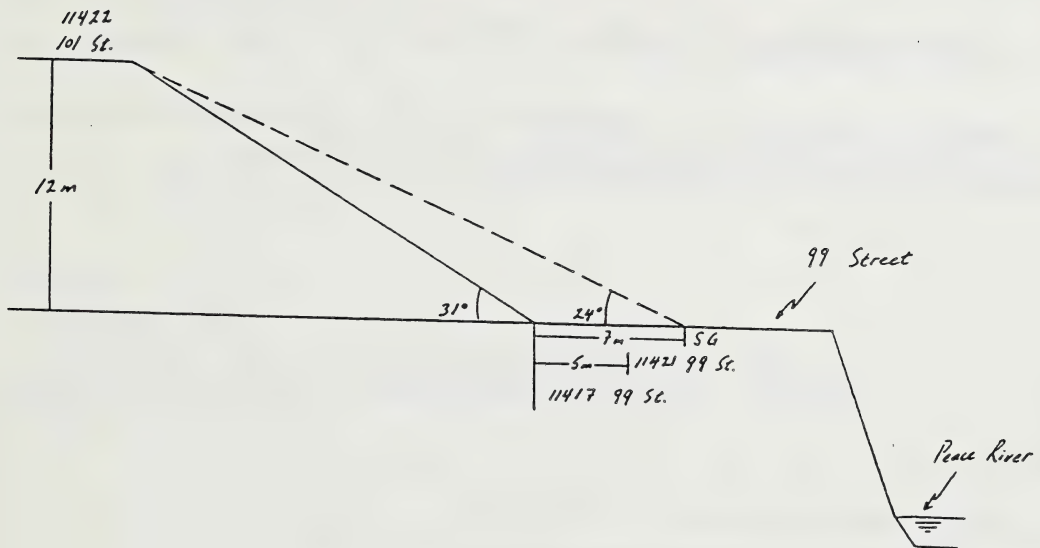
99 St. Slide, Peace River Town

Hs - slope height = 12 m (orthophoto measurement)

Bu - ultimate angle of stability = 24°

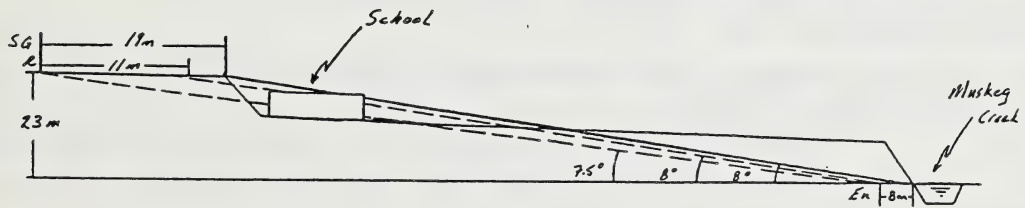
Athabasca Elementary School Slide

The northwest corner of Athabasca Elementary School was damaged by a landslide in 1968 to the extent that this part of the school had to be demolished. The thirteen residences along both sides of Davis Street immediately north of the

school were examined for damage. It was found that the seven houses on the east side of the street had not been damaged by the slide, while the six houses on the west side of the street had all been damaged to some extent. The northernmost house (adjacent to Morgan Avenue) was abandoned, as the distortion of the superstructure was too severe to consider salvaging (Hardy and Associates, 1970). It was also necessary to replace the gas service connection to these houses with flexible hoses.

It is believed that this major landslide was initiated when Muskeg Creek (originally named Spring Creek) began down-cutting rapidly following similar rapid down-cutting of the Athabasca River. When the erosion reached a critical depth, massive landsliding took place, possibly along deep zones of weakness or bedding planes in the clay shale bedrock. The creek is now eroding material along the outside of meanders at only a slow rate, but this is sufficient to continue to cause movement of the landslide along the original surfaces of rupture (Hardy and Associates, 1970). Also contributing to the active state of the landslide is the poor natural surface and sub-surface drainage in the area, which has led to a high groundwater level.

Hs - slope height = 23 m (Hardy R.M. and Associates, 1970)

Bu - ultimate angle of stability = 7.5°

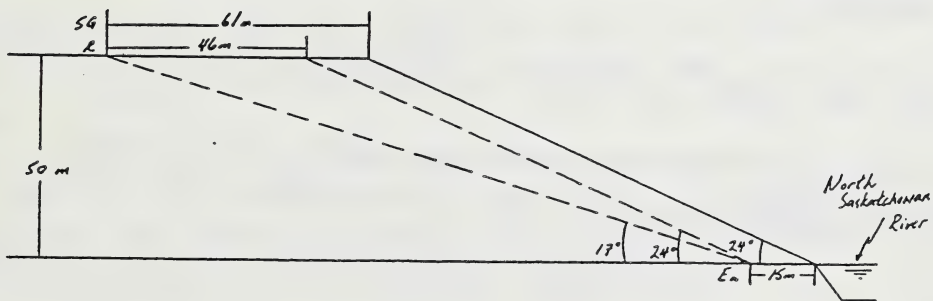
Grierson Hill Slide, Edmonton

The total crest retreat of the Grierson Hill Landslide between 1900 and 1958 was 43 m (Pennell, 1969) which is quite comparable to the potential long term regression of 46 m. It was not possible to determine where the structures were initially located relative to the slope crest, but they were apparently too close.

Hs - slope height = 50 m (Poppitt, 1963)

Bu - ultimate angle of stability = 17°

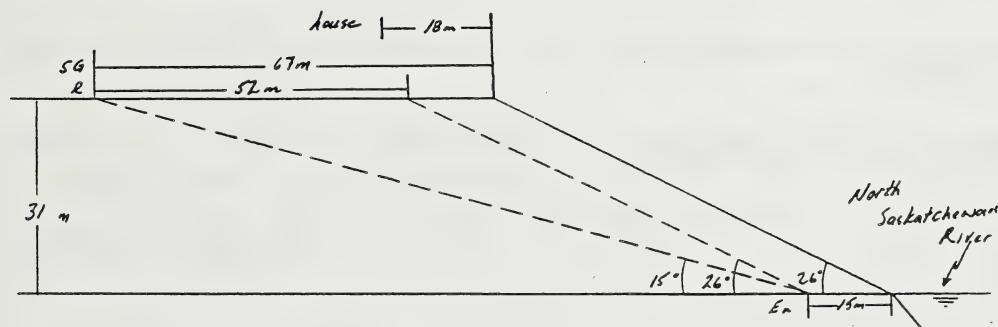
Lesueur Slide, North Sask. R., Edmonton

Hs - slope height = 31 m (Thomson, 1971)

β_u - ultimate angle of stability = 15°

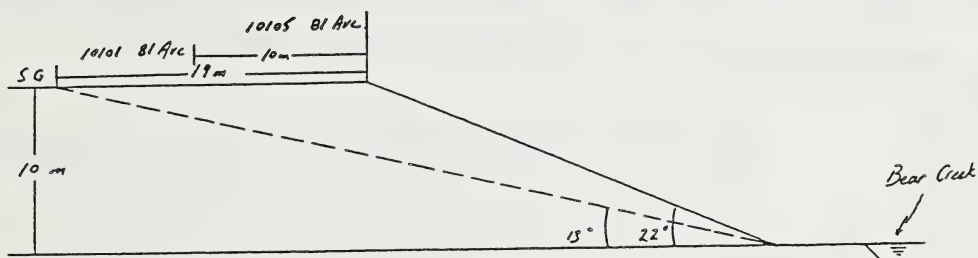
Mission Heights, Grande Prairie

The scarp of the Mission Heights Landslide extended up to the centre house (10105 81 Ave.) and was within 3 m of the southwest corner of the second house (10101 81 Ave.). All the structures (including the third house) were built within the setback guideline of 19 m. The house at 10101 81 Avenue was built approximately 10 m back from the crest, and the house at 10105 81 Avenue was built up to the crest.

Hs - slope height = 10 m (orthophoto measurement)

β_u - ultimate angle of stability = 13°

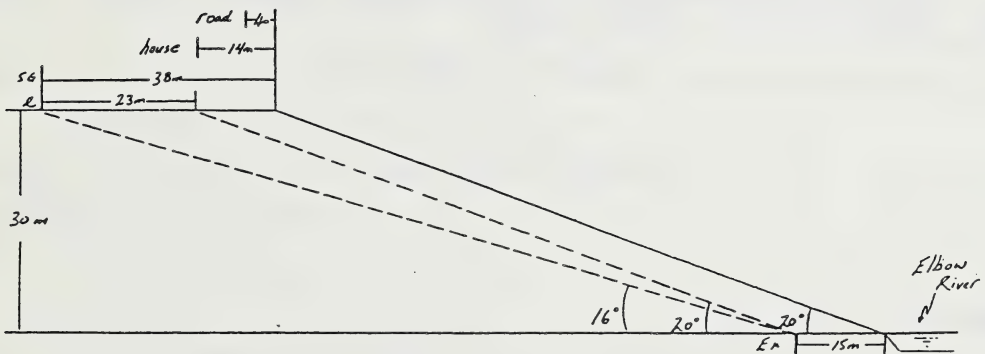
Park Hill Slide, Calgary

High groundwater pressures are presumed to be the cause of this landslide. The groundwater table was within 1 m of the slope surface (Hardy et al., 1980). This high water level is anomalous. Bulging occurred towards the base of the slope, but did not extend out into the river.

Hs - slope height = 30 m (Hardy et al., 1980)

Bu - ultimate angle of stability = 16°

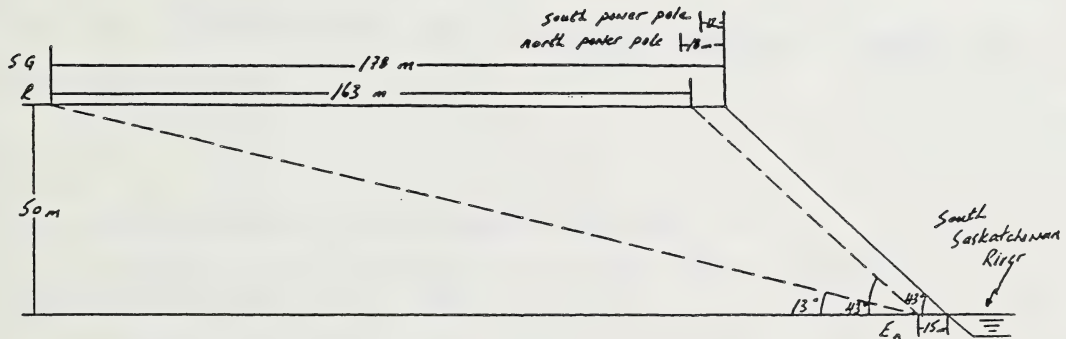
Power Plant Slide, Medicine Hat

Hs - slope height = 50 m (MacKay and Thomson, 1980)

Bu - ultimate angle of stability = 13°

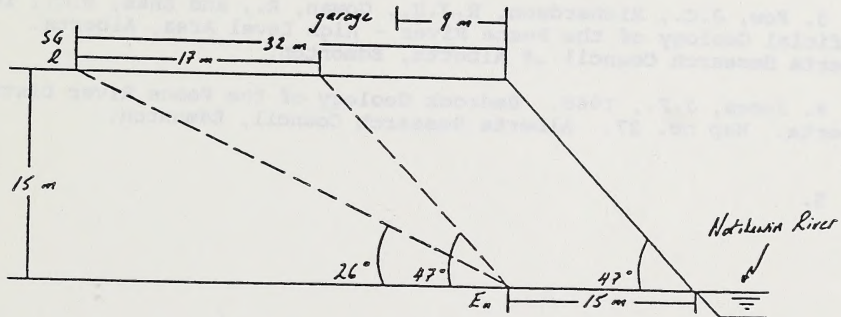
Schoendorfer Slide, Manning

Hs - slope height = 15 m (Surveys and Mapping Branch, 1976)

Bu - ultimate angle of stability = 26° (field measurement)
